L115W-11-315

**Subject:** Global Alternative Method of Compliance (AMOC) to Airworthiness Directive (AD) 2011-07-13 paragraph (g) "inspection and repairs" – Proposing a different method of inspection to inspect the outboard elevator hinge brackets and the elevator spar behind the bracket for cracks

**Reference:** (1) AD 2011-07-13 – on CPAC Inc Commander Models 112, 112B, 112TC, 114, 114A, 114B, and 114TC  
(2) Commander Owners Group (COG) email dated April 18, 2011 requesting an AMOC to AD 2011-07-13 paragraph (g)-proposing an alternate method for inspection.

### Alternative Inspection Procedure for AD 2011-07-13

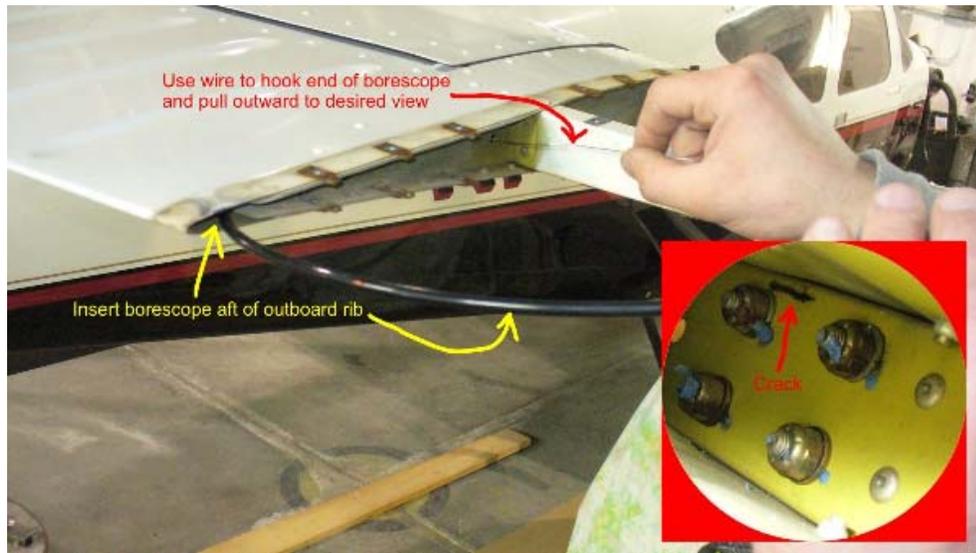
- b. **Shortened rib used in most later models.** Insert the borescope between the aft end of the outboard elevator rib and the trailing edge of the elevator skin (see picture below).

Inspection should cover the areas surrounding the four attachment nuts and extending upward and downward to the elevator skins and at least 1" inboard and outboard from the nuts. If suspect areas are noted, proceed to Step 4.
